Function checklist for the ML-350 or XL-350 with a 260217 print set.

Below mentioned check-point should resolve function problems of the lift systems.

Functie checklist voor een ML-350 of XL-350 met een 260217 printset.

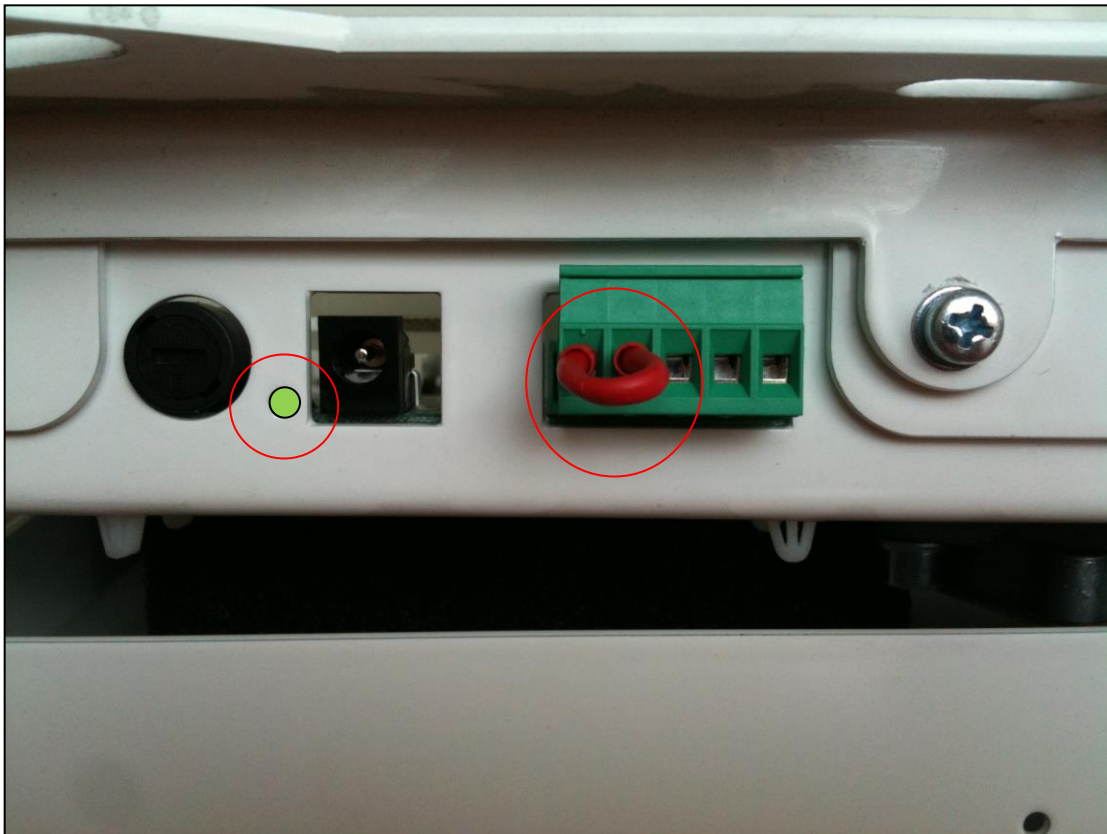
Missing loop.

When a lift is connected to an external control, make sure the red loop is connected to the external connector. This loop can be removed and replaced for an external safety switch (NC). When the loop is missing and no safety switch is used, the lift will not work.

Check the green LED for "system on" when inserting the 24 volt 1-2 A. power supply.

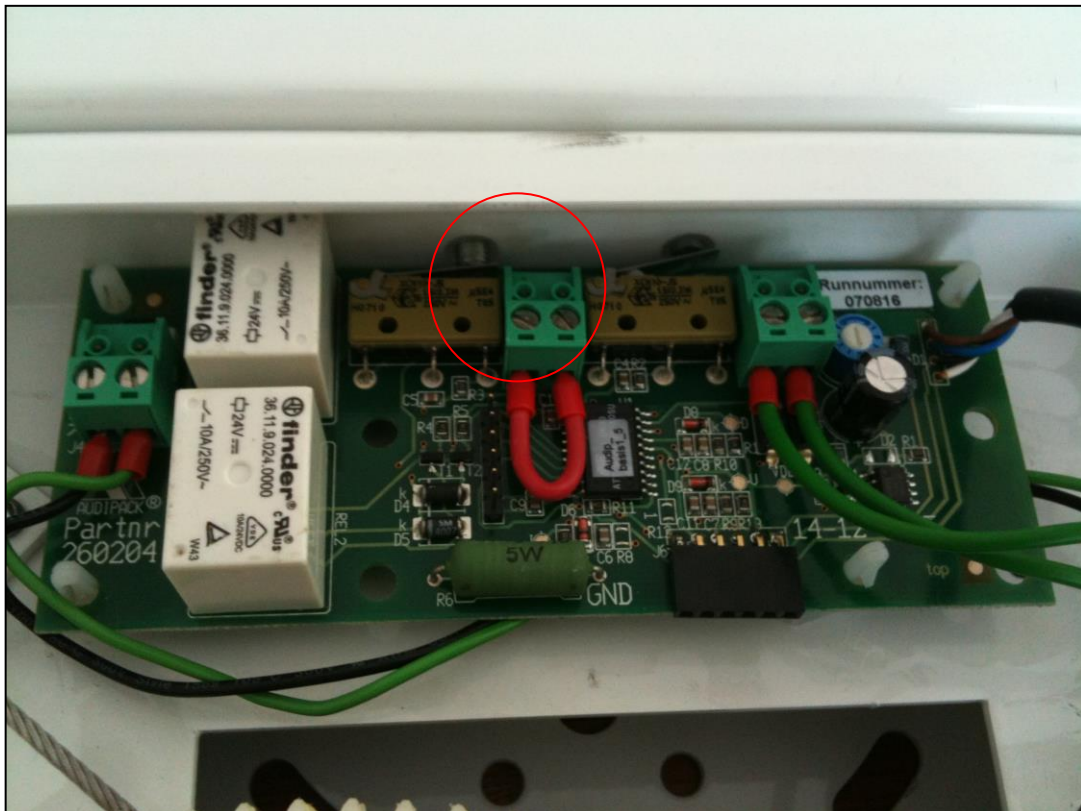
Removed loop connector (j2).

In some cases rough transport may result in a removed loop bridge on the PCB.

The loop missing on connection j1, will result in a proper working lift, but with a missing end-stop in DOWN direction!.

Beware!

The UP limit switch will not work

The DOWN limit switch will work!

The cable drum limit switch connected on j1 will NOT work.

Possible damage will be found in a broken sprocket (white) and the end switch rod will bend.

Please check the correct position and fitting of all 3 connectors.

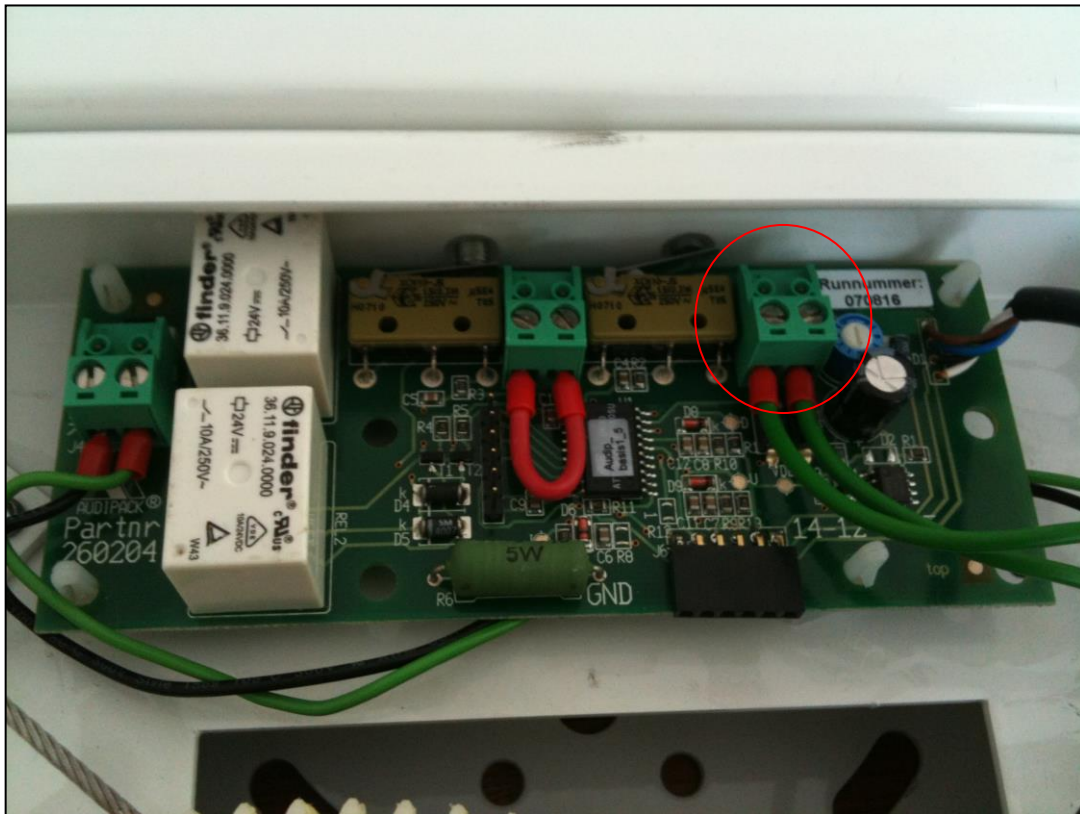
Removed connector (j1).

In some cases rough transport may result in a removed loop bridge on the PCB.
Please check the correct position and fitting of all 3 connectors.
The loop missing on connection j1, will result in a proper working lift, but with a missing end-stop in DOWN direction!.

The DOWN limit switch will not work
The UP limit switch will work!
The cable drum limit switch connected on j1 will NOT work.

Possible damage will be found in a broken sprocket (white) and the cable will bend.

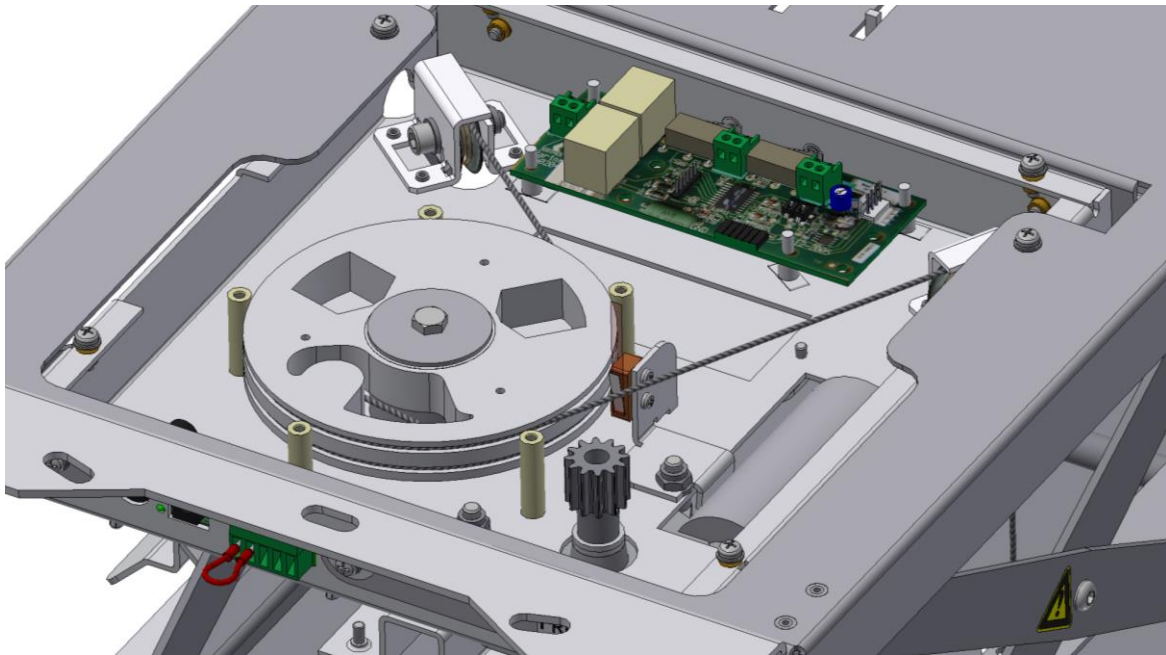
Activated limit switch will stall the lift.

When this particular switch is activated.

When the cable is not wound up properly in the drum, or the cable is wound off too much, it will activate the safety limit switch. The limit switch should never be activated unless there is a problem. Correct the cables in the drum and set free the switch before installing the gear.

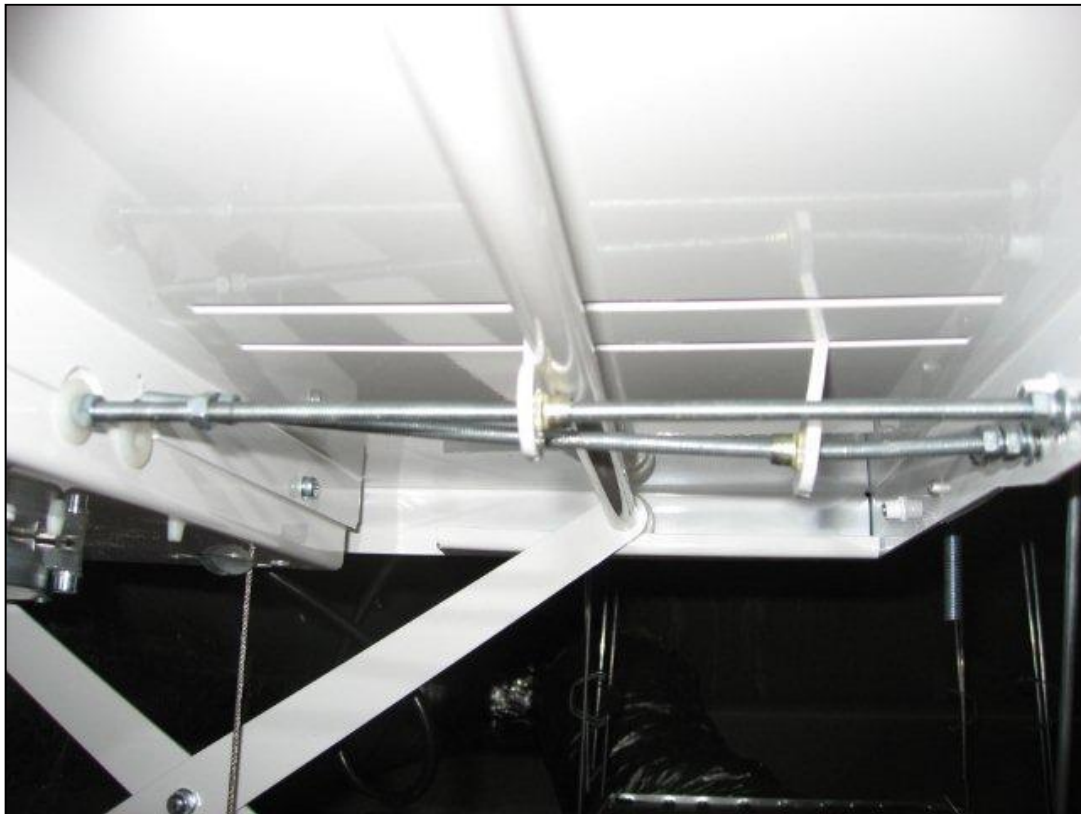
“stuck lift”.

When a lift does not move in both directions but gives a small “shock” both end-switches are activated. Check that both or at least one end switch is free to move. Only 1 will move of course when the other is activated by the lift. It is never allowed that both switches are activated.

In occasions it might appear the the limit switch windings are bended. This happened only when the lift is pushed HARD to the construction ceiling. The UP limit switch is already activated but then extra pushed when pressing the lift to the ceiling. Bended switch windings result a limited liberty of movement.

When the upper mentioned check-point do not help preventing the problem please contact Audipack.

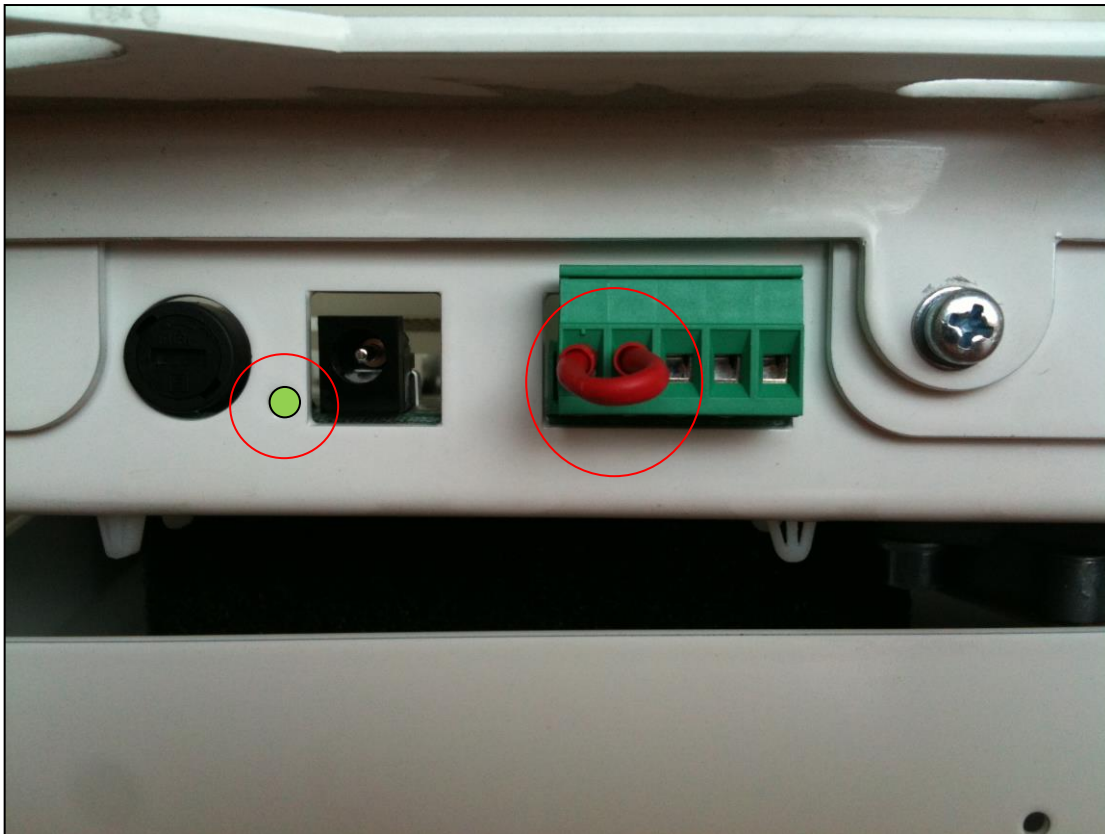
Missende brug.

Indien een lift wordt aangesloten dient er te allen tijde een loop geplaatst te worden op de algemene aansluiting van de lift. Deze loop kan vervangen worden voor een externe noodstop (NC).

Indien deze loop niet aanwezig is zal de lift NIET functioneren.

Controleer of de groene LED brand zodra de 24 volt 1-2A. voeding is aangesloten.

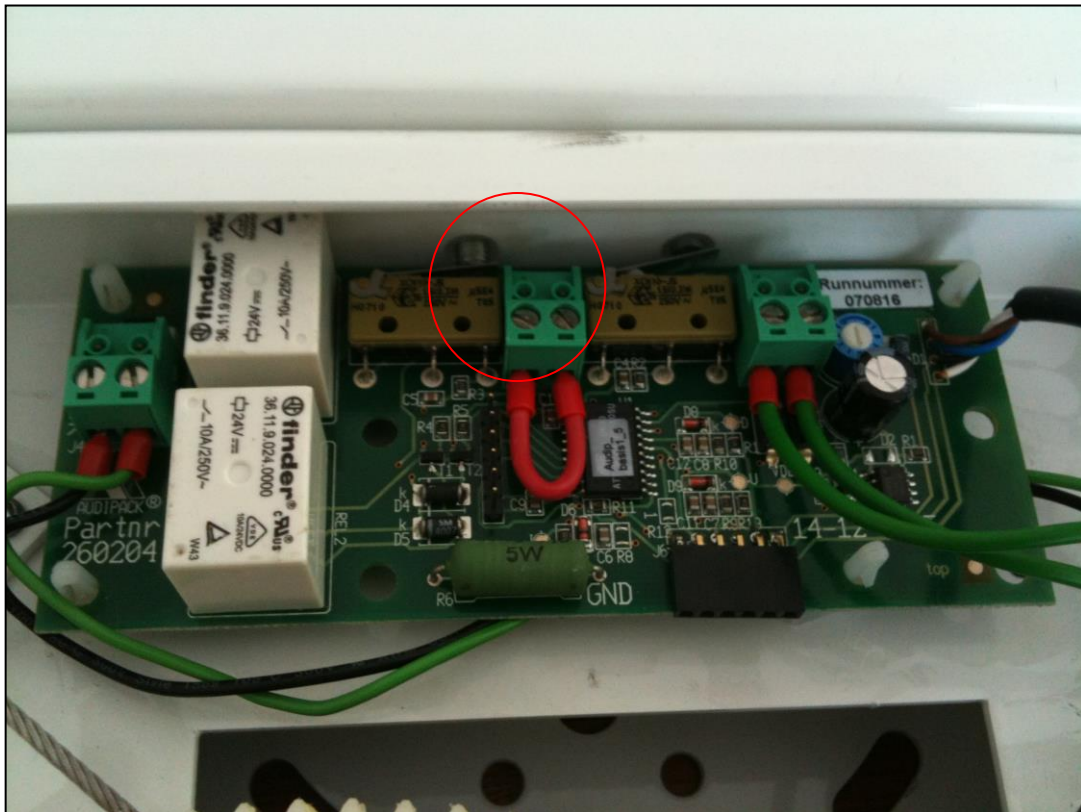
Los connectorblokje (j2).

Het is mogelijk bij ruw transport dat een connectorblokje **j2** is losgekomen van de printplaat. Controleer dat alle 3 de aansluitblokjes op hun plek zitten. Indien het connectorblokje los is kan de lift gewoon op-en neer bewegen.

De Down limietschakelaar werkt dan wel.
De UP limiet schakelaar werkt dan niet!!.

Mogelijke gevolg schade is dat de lift ongelimiteerd door blijft lopen naar boven toe en de tandwiel kan beschadigen en de afsteldraadeind krom maken van de UP schakelaar.

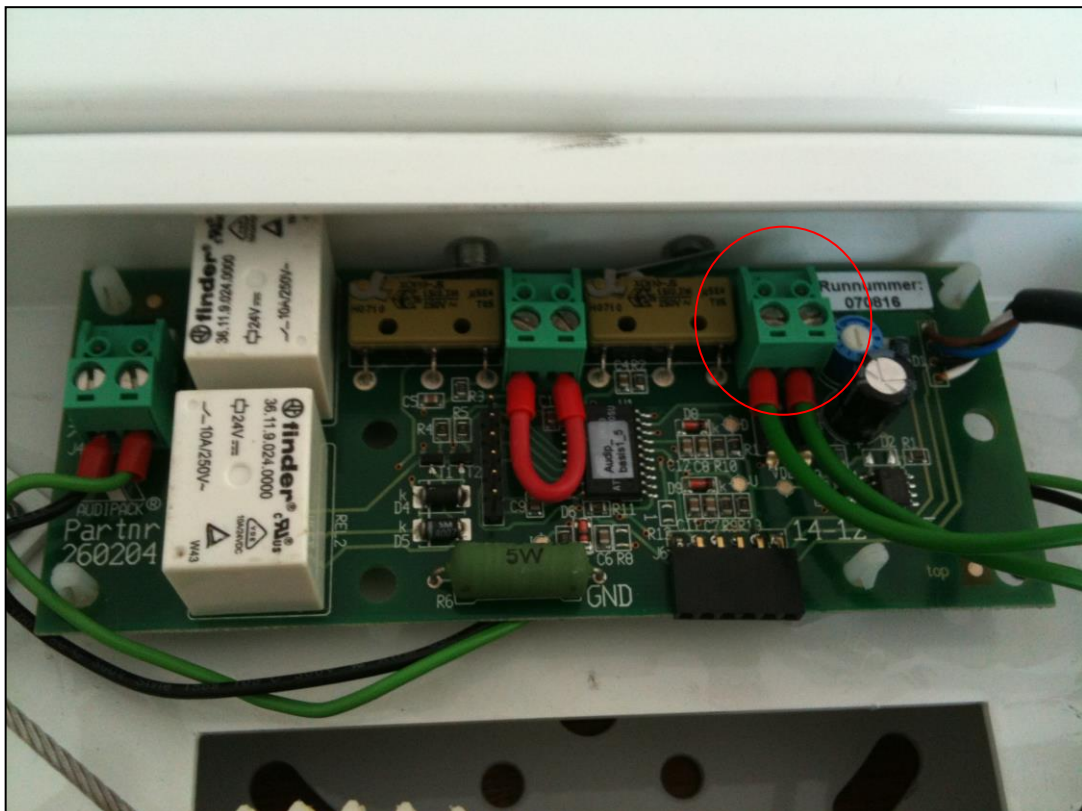
Los connectorblokje (j1).

Indien het connectorblokje los is kan de lift gewoon op-en neer bewegen.

De Down limietschakelaar werkt dan niet

De UP limiet schakelaar werkt dan wel!!

De anti doorloop schakelaar aangesloten op connector **j1** werkt dan niet.

Mogelijke gevolgschade is dat de lift ongelimiteerd door blijft lopen naar beneden toe en het tandwiel kan beschadigen. Tevens kan er een knik in de staalkabel komen.

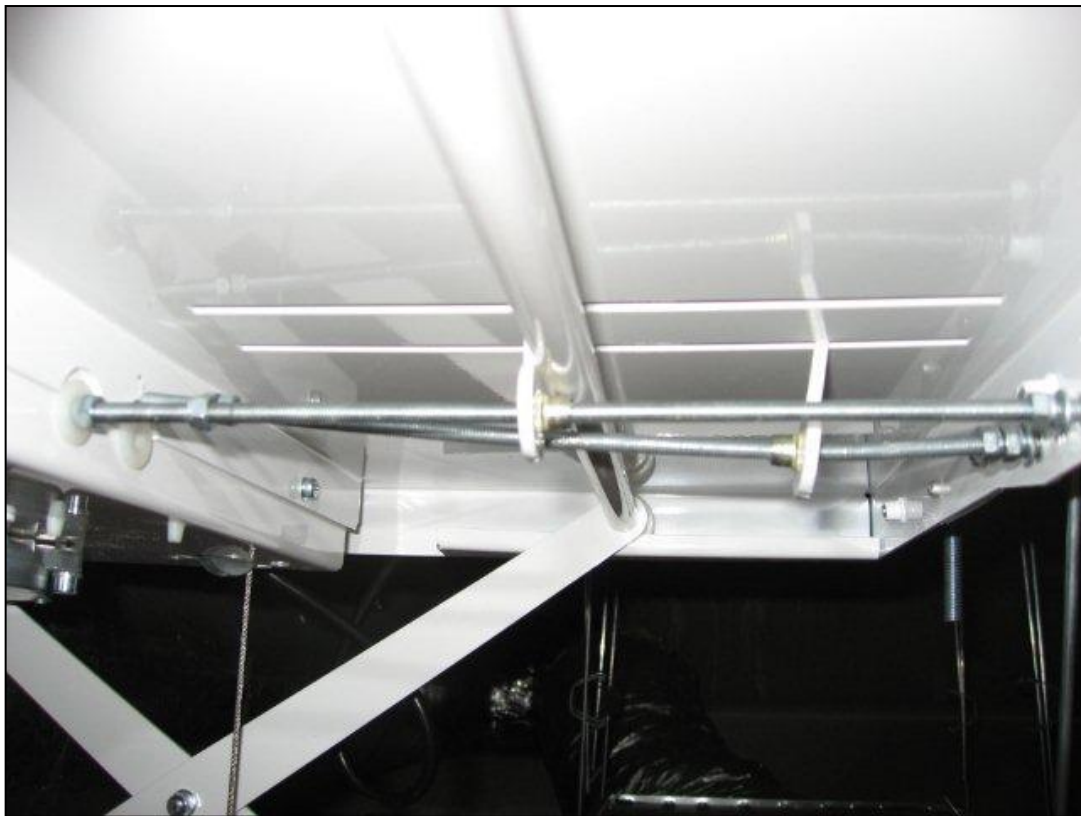
“Vastzittende lift”.

Indien de lift in beide richtingen schokt bij het geven van een commando, maar niet op-en neer beweegt, zijn beide eindschakelaars geactiveerd. Controleer of de schakelaars vrij kunnen bewegen (mits er 1 reeds is geactiveerd). Er mogen nooit 2 schakelaars geactiveerd worden.

Meestal komt dit als 1 van de schakelaardraadeinden krom is, vaak veroorzaakt tijdens de installatie.

Het overmatig aandrukken van de lift tegen het bouwkundig plafond kan een buiging geven van de schakelaarverstelling. Door de kromming kan de schakelaarverstelling vast gaan zitten in de glijlagers.

Indien de bovenstaande check-points geen oplossing hebben kunnen bieden adviseren wij u contact op te nemen met de serviceafdeling.
